AFRL-PR-WP-TR-2002-2061

**JP-8+100 ENGINE DEMONSTRATION
Industry Version**

MARCH 2002

Final Report for 23 June 1995 – 30 July 2000

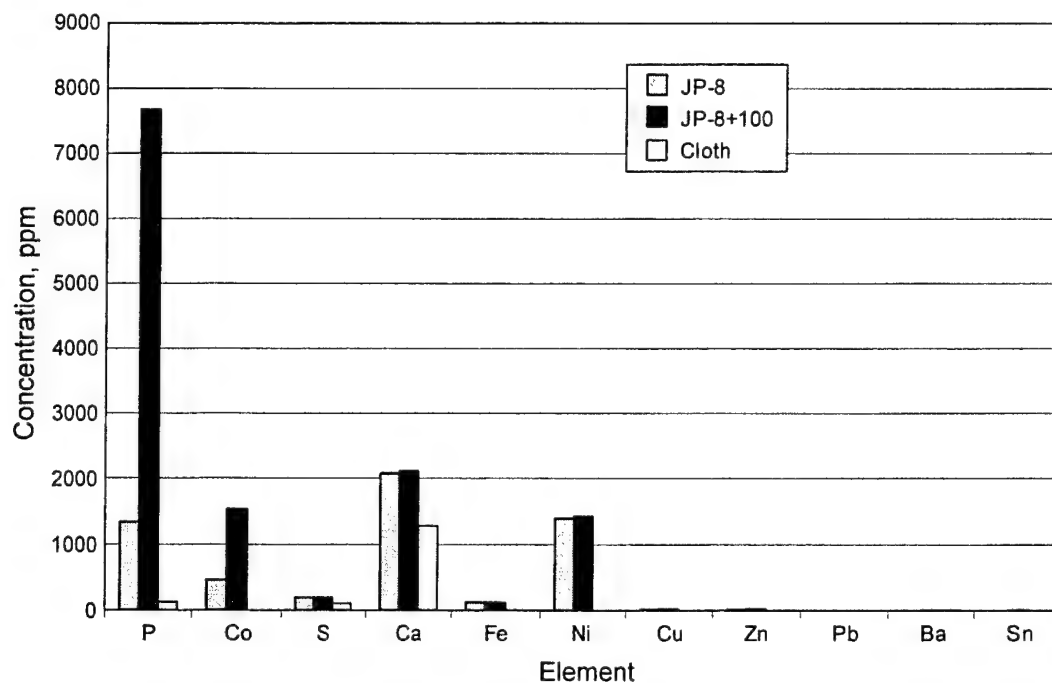
Figure 26 Elemental Analysis of Surface Coating From 1st Stage Turbine Blades of TF34 Engines Operated on JP-8 and JP-8+100

Figures 26 and 27 summarize the results of these analyses from the blade deposits as well as the paper towel itself. The only significant contribution from the paper towel was Ca; small quantities of S and P were also found. The major differences between the blade analyses are the increases in P and Co in deposits from the engine operated on JP-8+100. Concentrations of the other constituents were essentially the same.
